POTOMAC RIVER BASIN

Name Of Dam: NEWMAN LAKE DAM  
Location: HARRISONBURG, VIRGINIA  
Inventory Number: VA. NO. 66001

# PHASE I INSPECTION REPORT NATIONAL DAM SAFETY PROGRAM

SCHNABEL ENGINEERING ASSOCIATES, P.C./  
J. K. TIMMONS AND ASSOCIATES, INC.

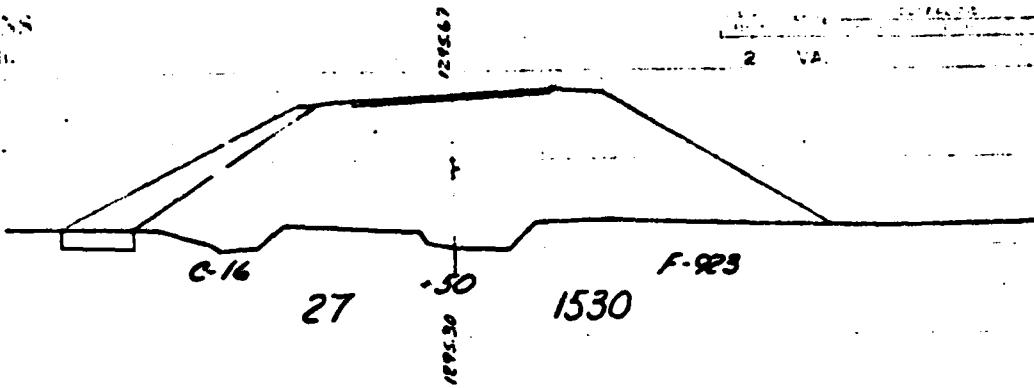
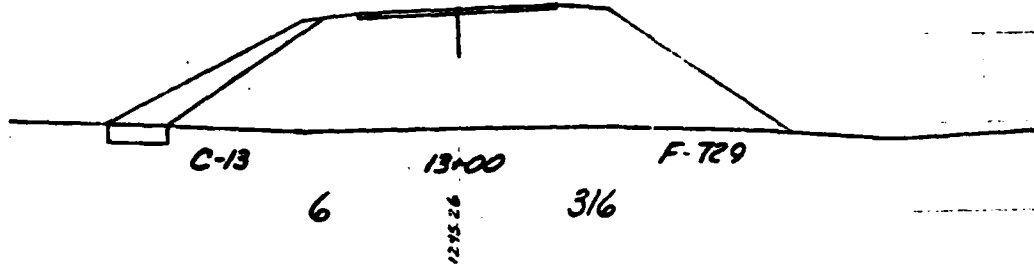
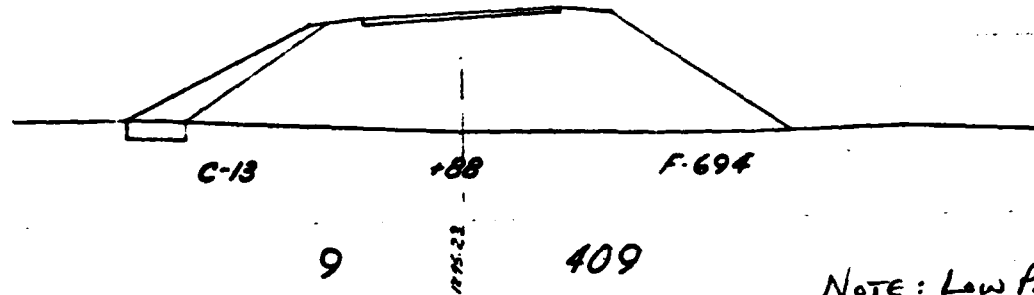
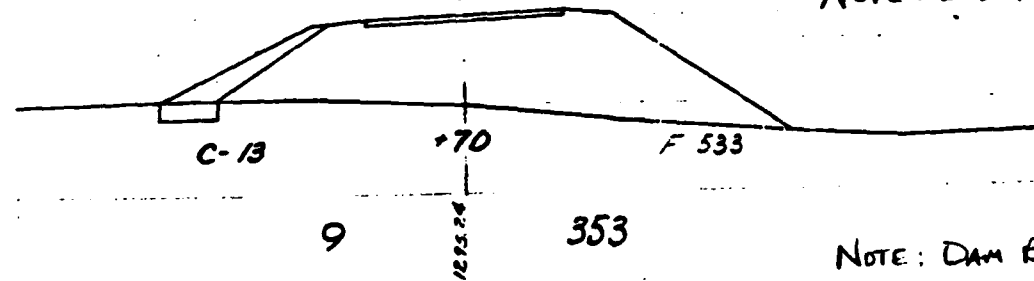
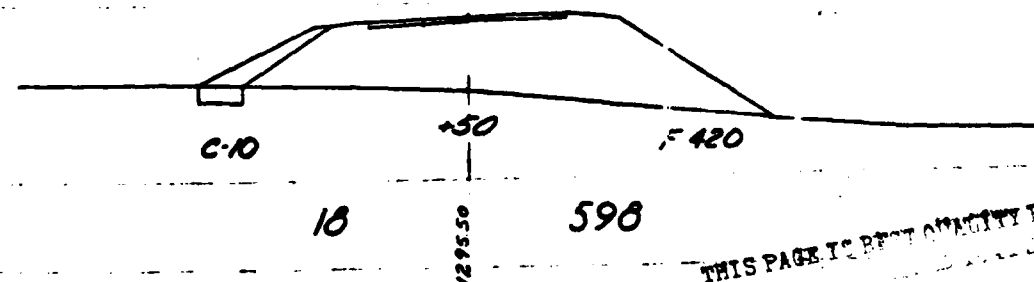
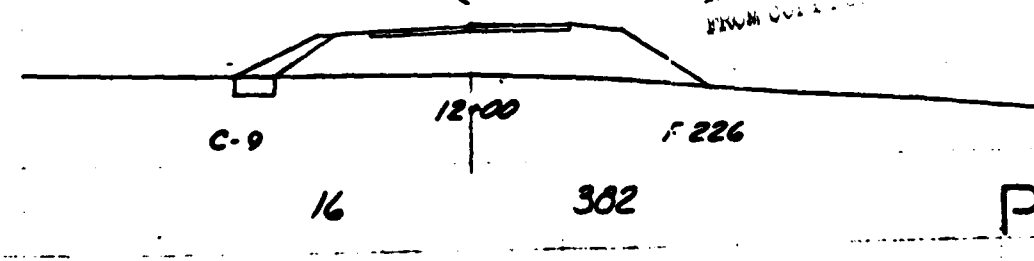
PLATE NO. 6

6.2.3 Stability: There are no available stability calculations. The dam is 17 ft high and has a bottom width of approximately 90 ft and crest width of 35 ft along the principal spillway section of the dam (Sta. 13+50, Plate No. 6, Appendix I). Both the upstream and downstream slopes range from 2.5H:1V to 3H:1V. The dam is subject to rapid draw-down, because the approximate reservoir draw-down rate of 5.4 ft per day exceeds the critical rate of 0.5 ft/day for earth dams. Design drawings (Plate No. 2, Appendix I) show an upstream slope of 1.5 H:1V with a specified compacted blanket of variable thickness (2H:1V slope) and keyed into the ground 2 ft. Based upon existing slopes and the

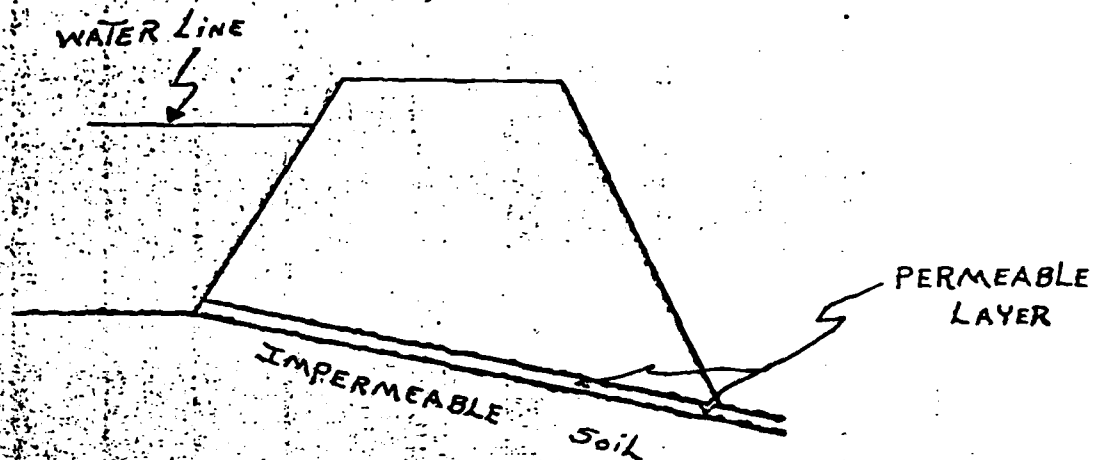
FIG. 1

2. Preliminary investigation indicates that the dam rests on a thin layer of permeable topsoil over an almost impermeable subsoil, as shown in Figure 1. Water is moving through the permeable layer and emerging near the downstream toe.

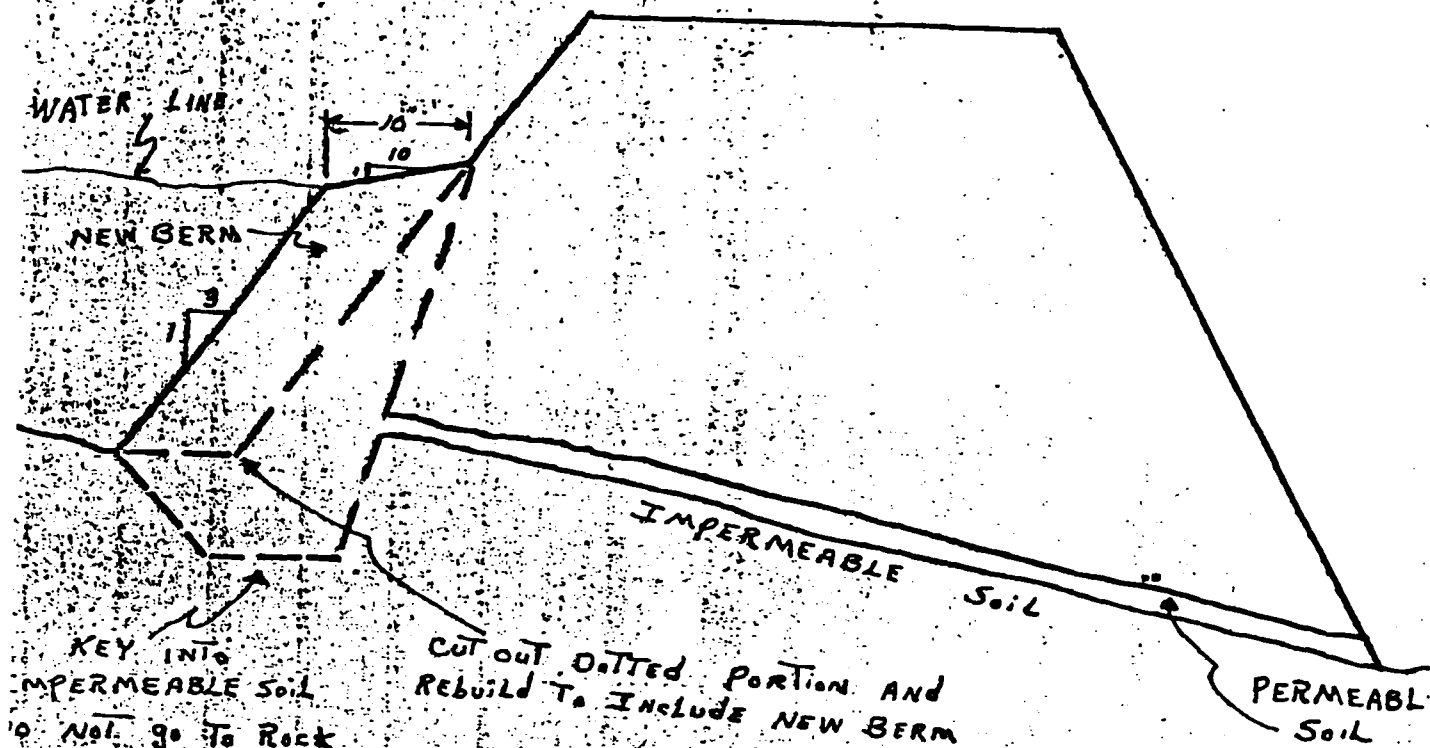
FIG. 3

An upstream cutoff, as shown in Figure 3, should adequately stop the flow of water through the dam making downstream drainage unnecessary for a dam this low. Advantages of this system are as follows:
